# ENVIRONMENTAL AUDIT REPORT

FY 2025–26

**NOIDA INSTITUTE OF ENGINEERING & TECHNOLOGY**  
**GREATER NOIDA, UTTAR PRADESH**

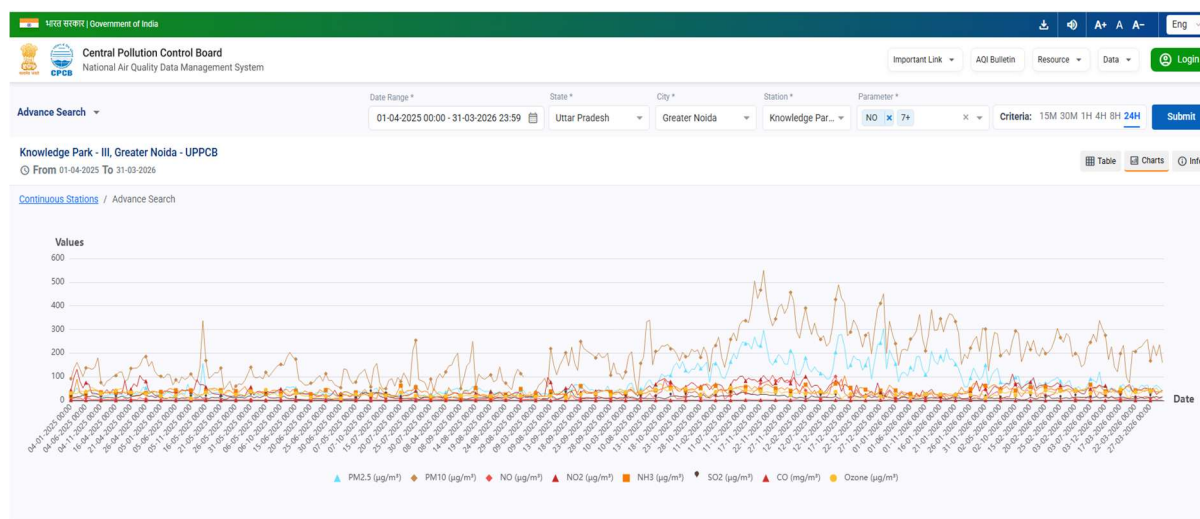
Ambient air quality data from the nearby UPPCB monitoring station (Knowledge Park - III, Greater Noida) indicate that particulate matter remains the primary air-quality concern in the area. Annual average  $PM_{2.5}$  and  $PM_{10}$  concentrations exceeded the applicable NAAQS, while  $NO_2$  showed a marginal annual exceedance.  $SO_2$  and  $NH_3$  remained within the prescribed limits, indicating comparatively lower concern for these gaseous pollutants during the assessment period.

Monthly analysis further indicates clear seasonal variation, with particulate concentrations generally increasing during the post-monsoon and winter months and comparatively lower levels during the monsoon period. This reflects the broader seasonal ambient air quality pattern of the Greater Noida region.

UPPCB monitoring station (Knowledge Park - III, Greater Noida)

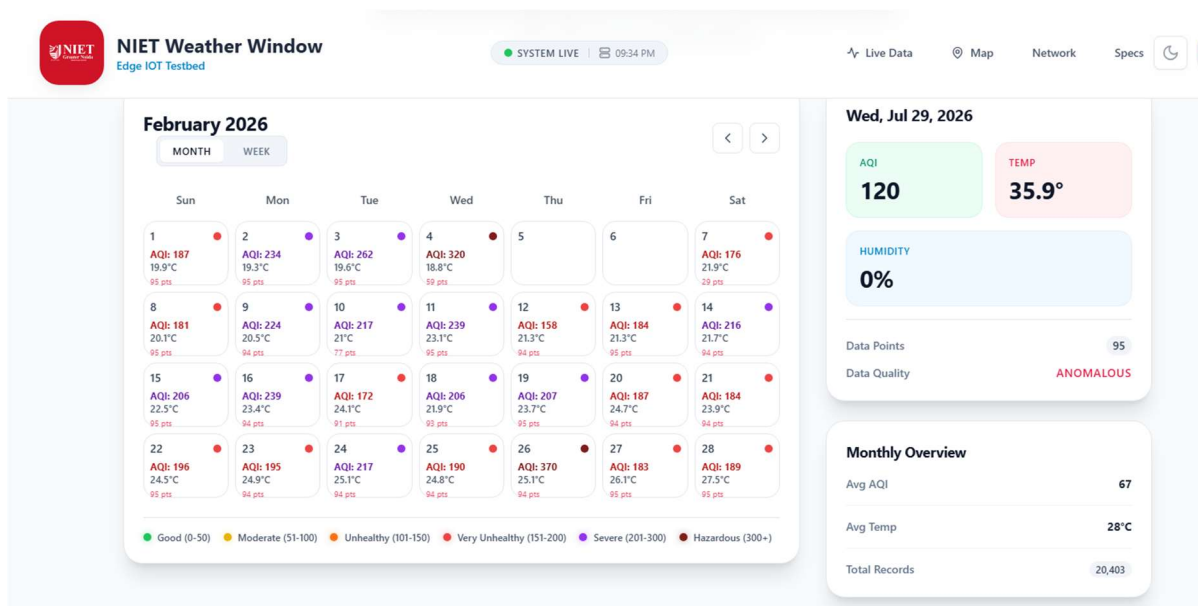
A real-time air quality monitoring system is also installed on the campus. In-house AQI monitoring indicates seasonal variation in campus air quality, with comparatively higher AQI levels during the winter period, particularly during January–March 2026, followed by noticeable improvement during the subsequent warmer months. The observed winter deterioration is broadly consistent with data from the nearby UPPCB monitoring station at Knowledge Park-III, where elevated  $PM_{2.5}$  and  $PM_{10}$  concentrations were also recorded during the winter period.

This suggests that campus air quality is influenced, at least in part, by the broader regional air-quality conditions of Greater Noida. However, the two datasets have been interpreted independently due to differences in monitoring methodology, AQI classification and data availability.

NIET Real-time AQI Monitoring Dashboard. (Link: <https://signodes-weather-window.netlify.app>)
